**CALIGUIRI PLAZA
WINDOW AND FAÇADE REPLACEMENT PA-1-41
HOUSING AUTHORITY OF THE CITY OF PITTSBURGH
R3A PROJECT NO. 14021**

**SELECTIVE DEMOLITION SITE OBSERVATIONS
024120**

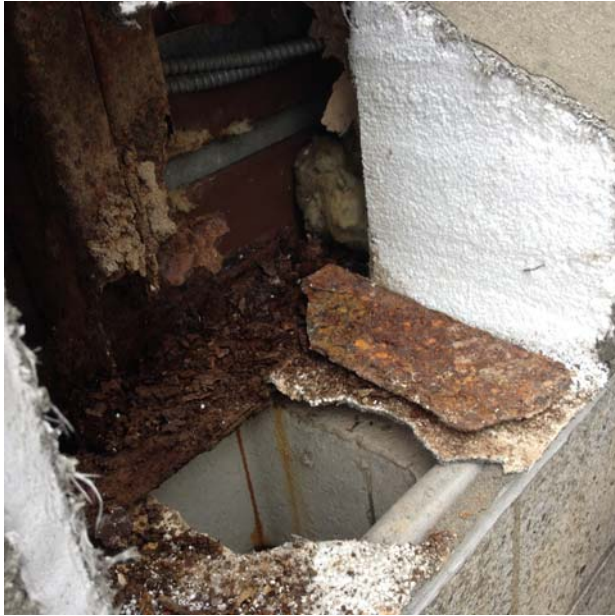
EX. DETERIORATED STEEL PLATES @ MASONRY BASE

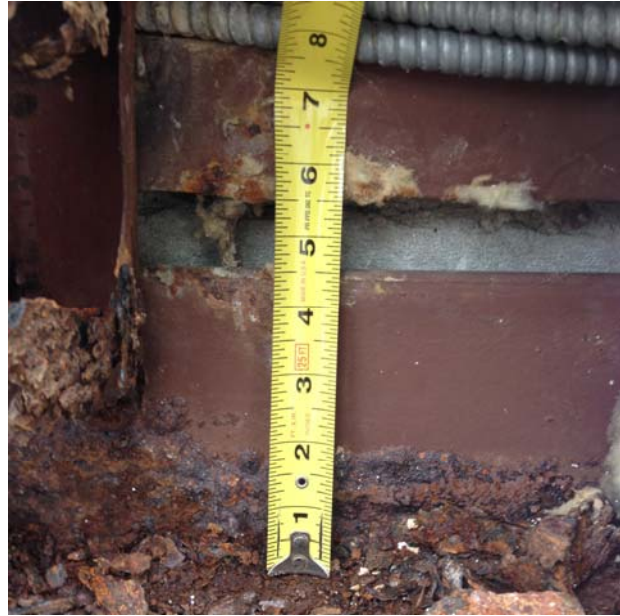
EX. DETERIORATED PLASTER AT CONCRETE PLANKS

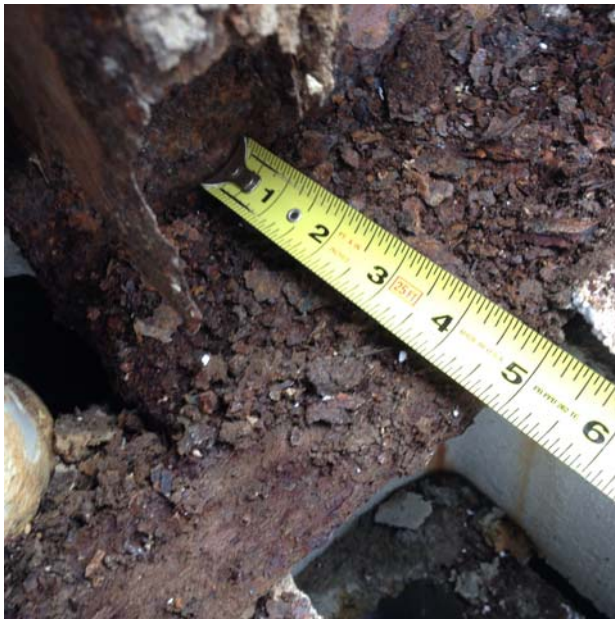
EX. DETERIORATED COLD FORMED METAL FRAMING

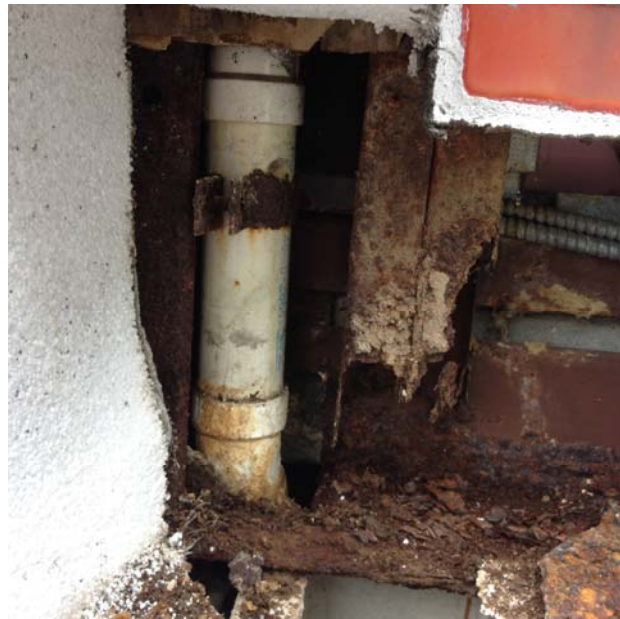
EX. DRAIN PIPE THROUGH PLATES

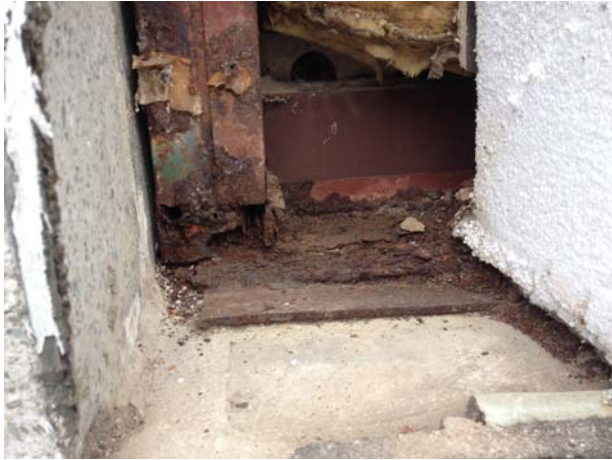
EX. DETERIORATED COLD FORMED METAL FRAMING

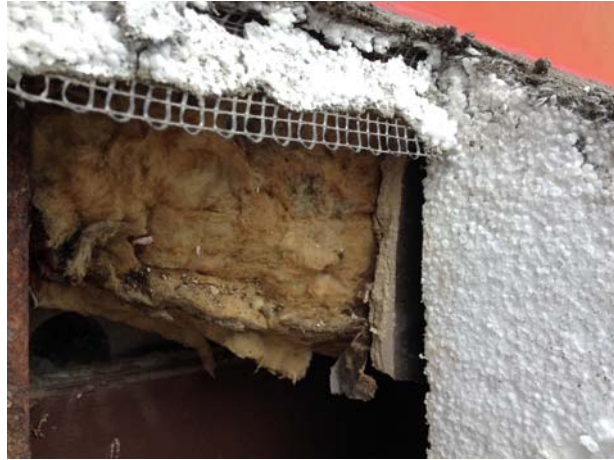
EX. WATER DAMAGED BATT INSULATION

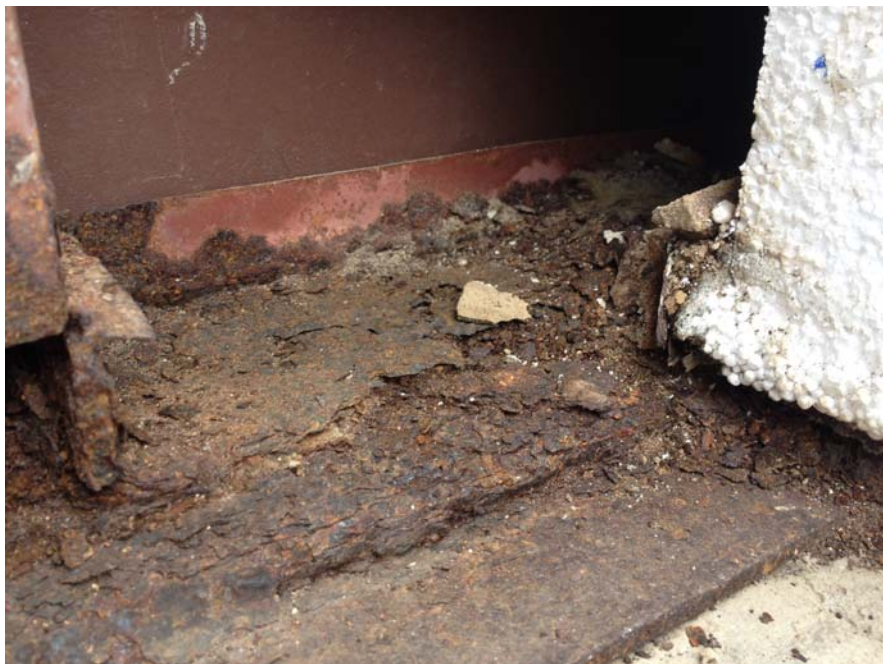
EX. DETERIORATED STEEL PLATES @ MASONRY BASE

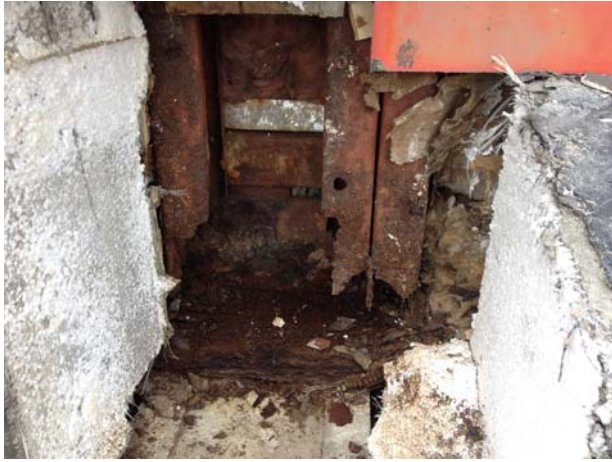
EX. DETERIORATED STEEL PLATES @ MASONRY BASE

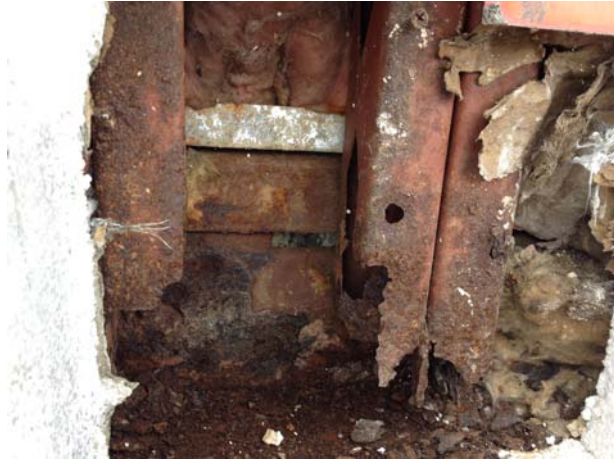
EX. DETERIORATED COLD FORMED METAL FRAMING

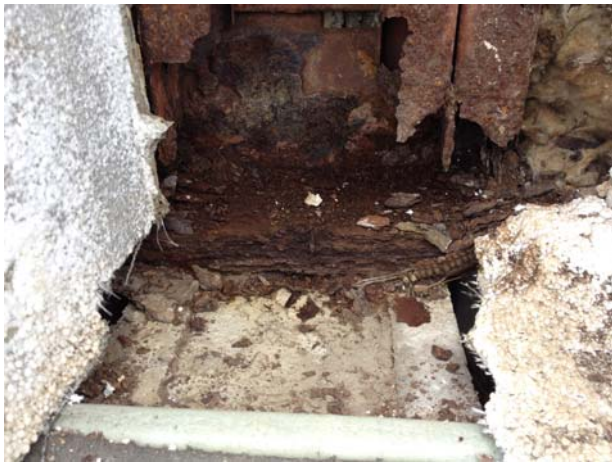
EX. MASONRY CELLS - PARTIALLY GROUTED

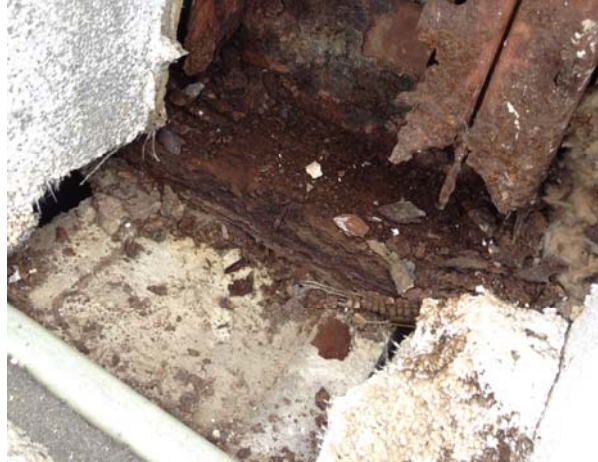
EX. MASONRY CELLS – PARTIALLY GROUTED

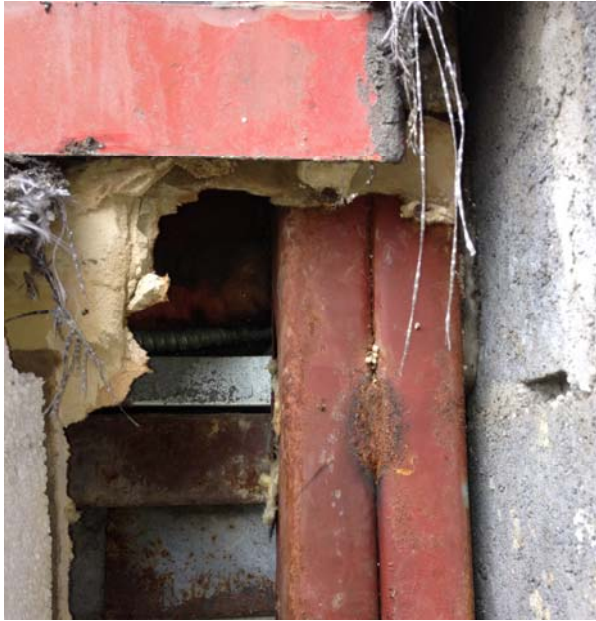
EX. STEEL ANGLES AT CONCRETE PLANKS

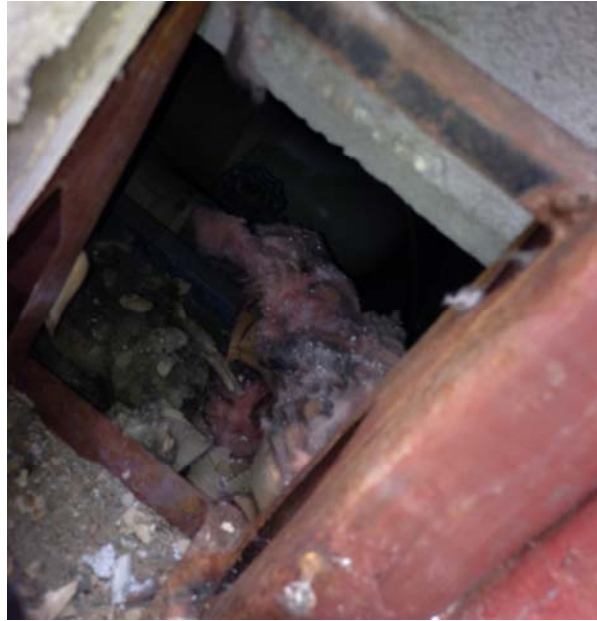
EX. BETWEEN CONCRETE PLANK AND MASONRY BASE

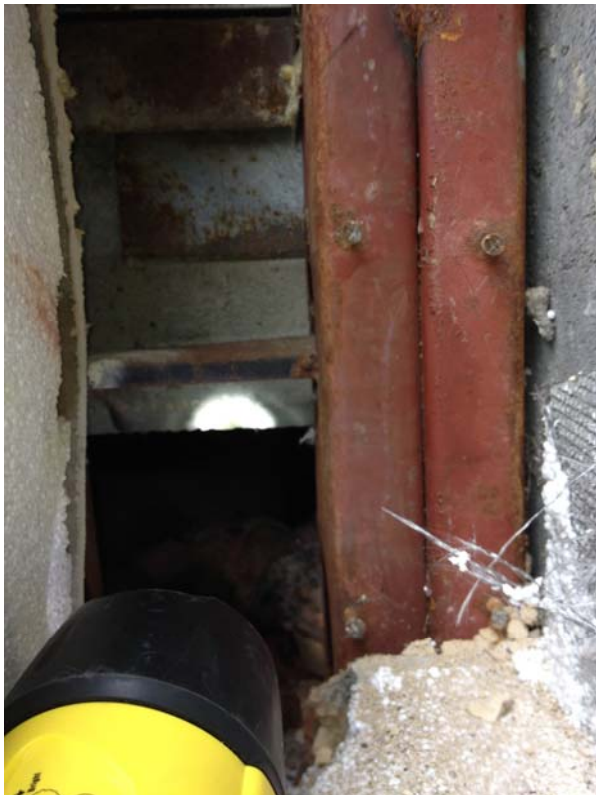
EX. STEEL ANGLES AT CONCRETE PLANK

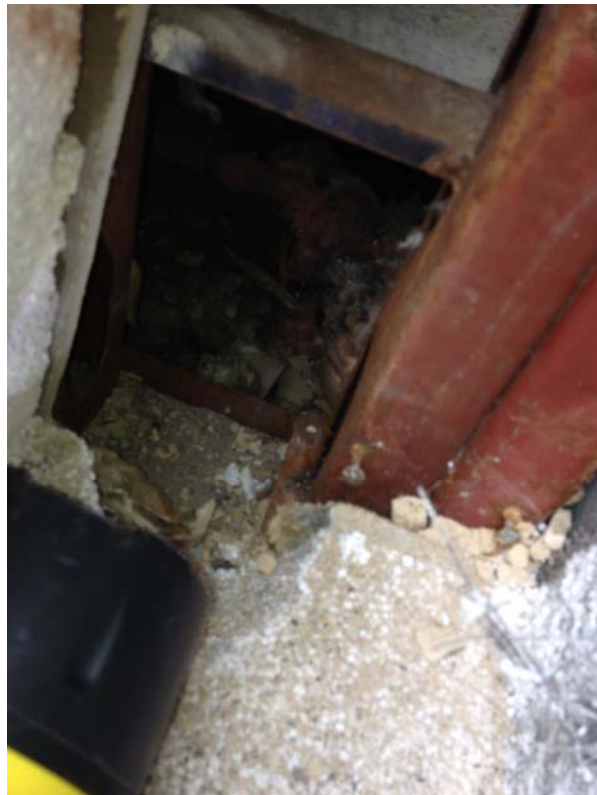
EX. BETWEEN CONCRETE PLANK AND MASONRY BASE

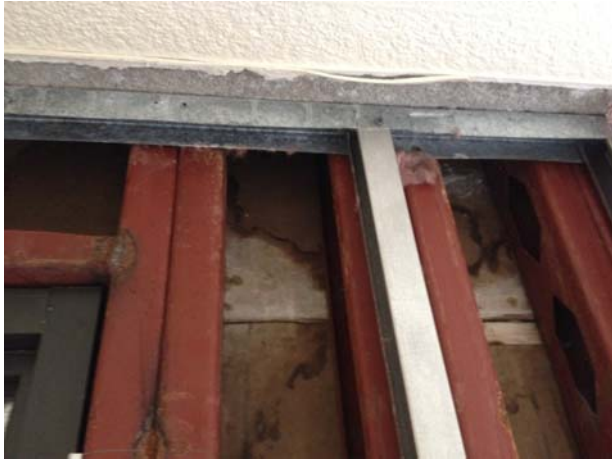
EX. COLD FORMED METAL FRAMING

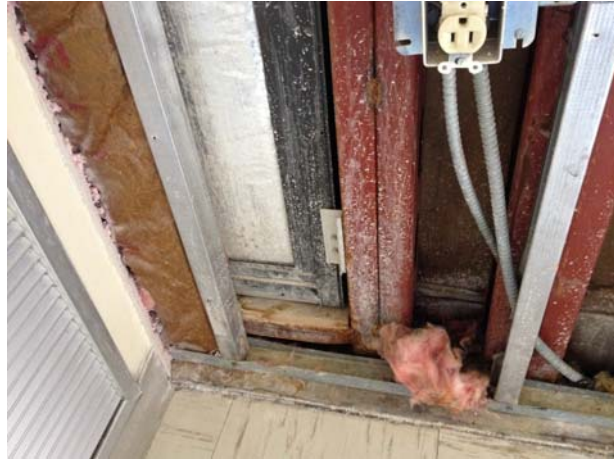
EX. WINDOW SYSTEM SECURED TO METAL FRAMING

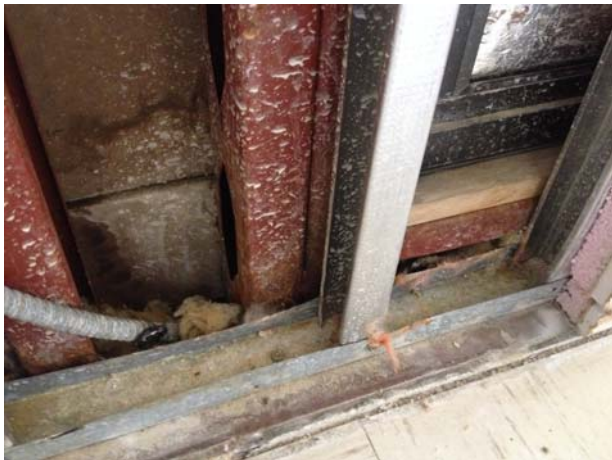
EX. FRAMING/INSULATION AND COLD METAL BEYOND

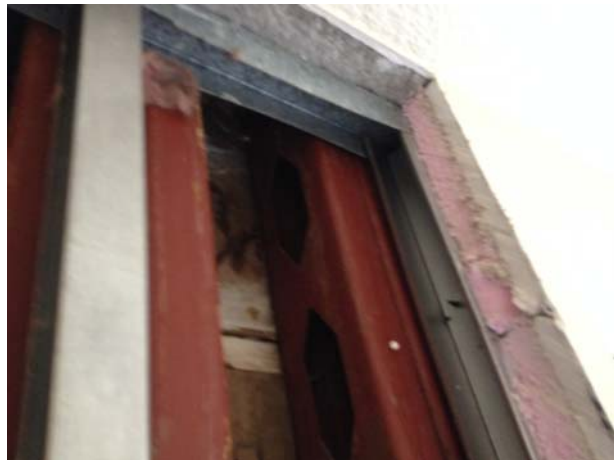
EX. FRAMING/INSULATION AND COLD METAL BEYOND

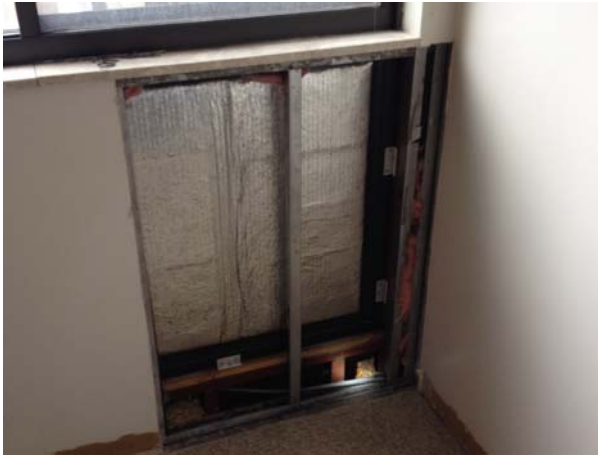
EX. WINDOW SYSTEM FRAMING

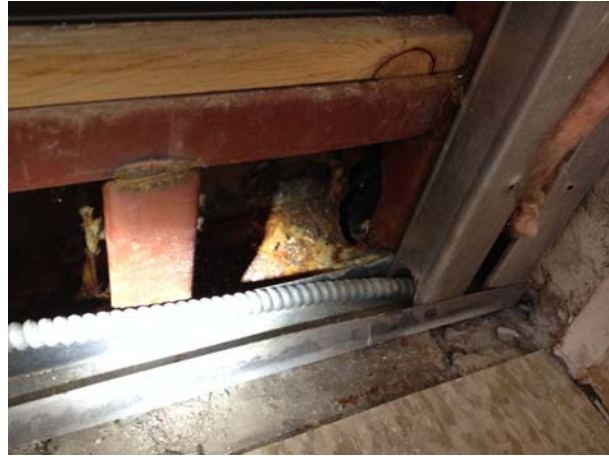
EX. DETERIORATED COLD METAL FRAMING @ WINDOW

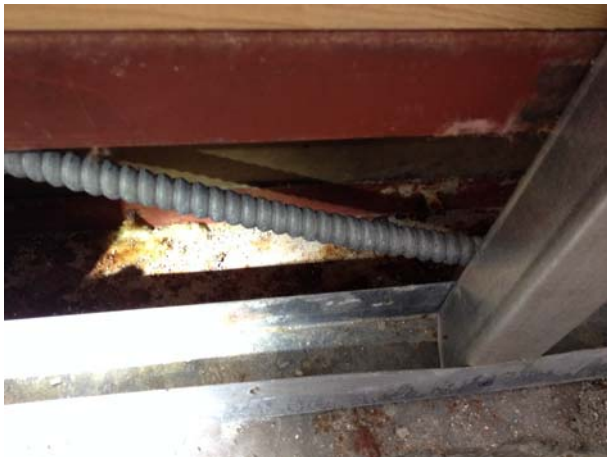
EX. DETERIORATED COLD METAL FRAMING @ WINDOW

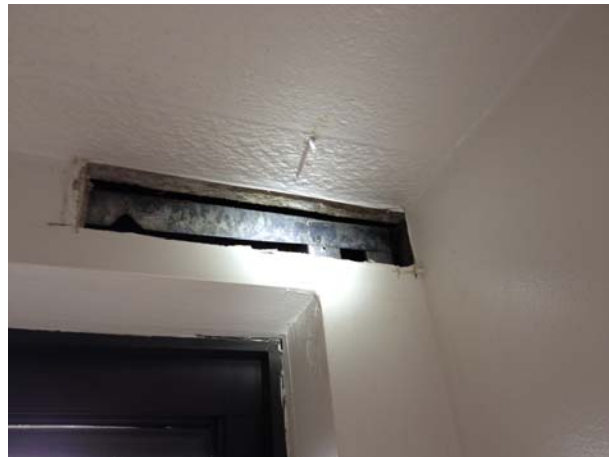
EX. VIEW OF FRAMING ABOVE WINDOW

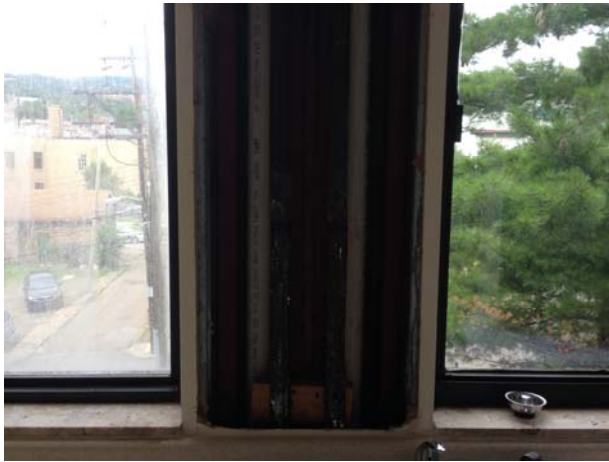
EX. PIPING AT KITCHEN SINK

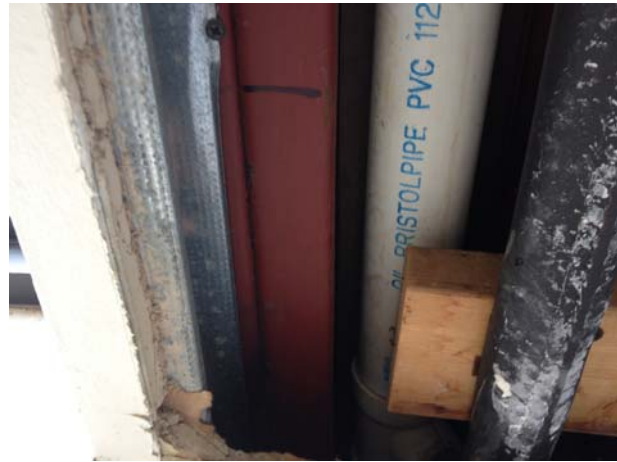
EX. FRAMING AND PIPING

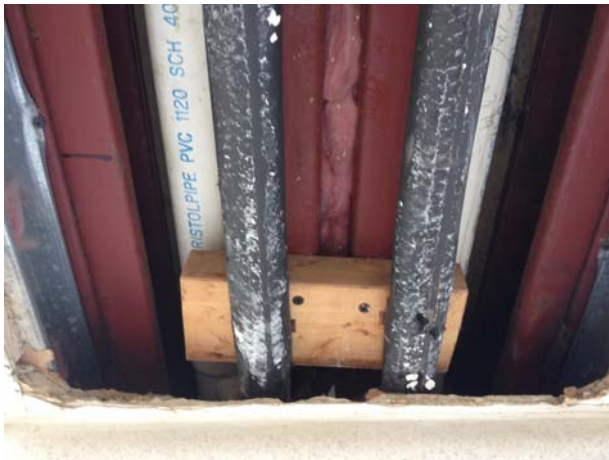
EX. INSULATED PIPING WITHIN FRAMING

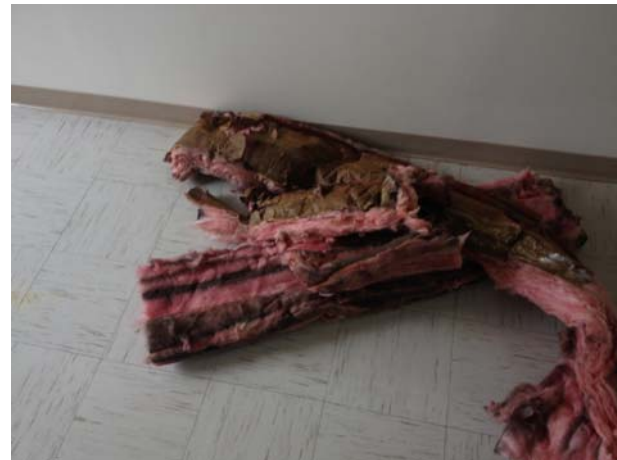
EX. WATER DAMAGED BATT INSULATION

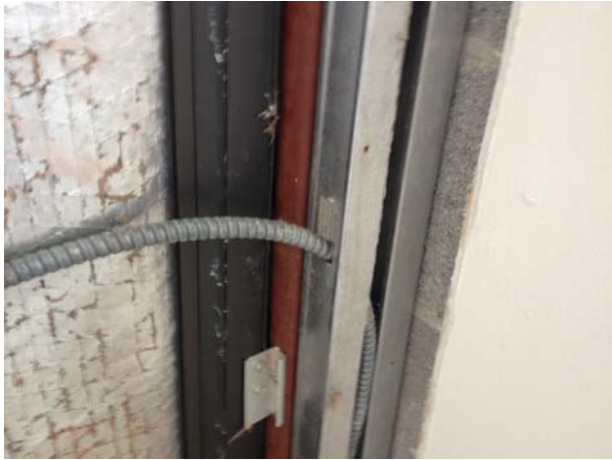
EX. CONDUIT @ METAL FRAMING BELOW WINDOW

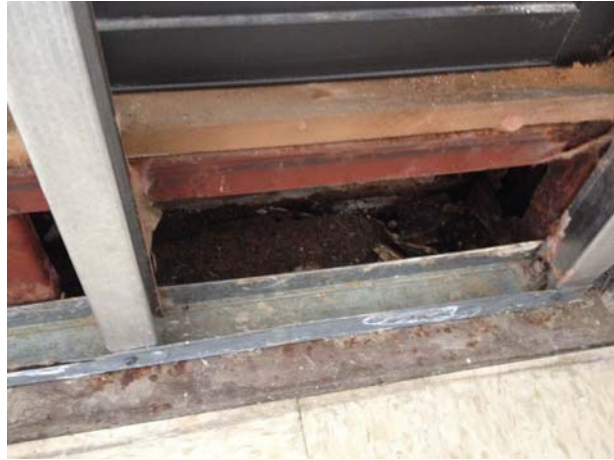
EX. DETERIORATED COLD METAL FRAMING @ WINDOW

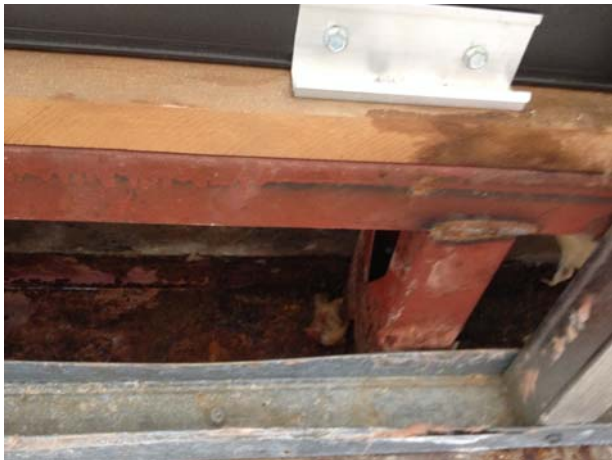
EX. DETERIORATED COLD METAL FRAMING @ WINDOW

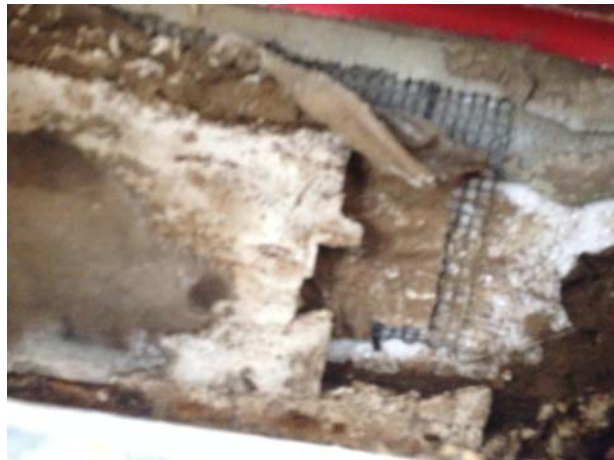
EX. DETERIORATED EIFS BELOW WINDOW

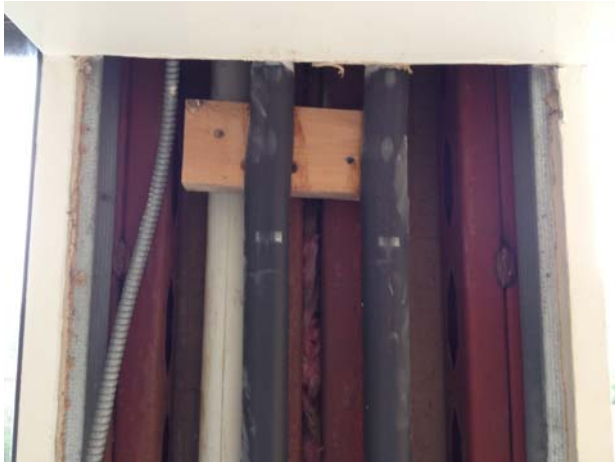
EX. INSULATED PIPING @ KITCHEN SINK

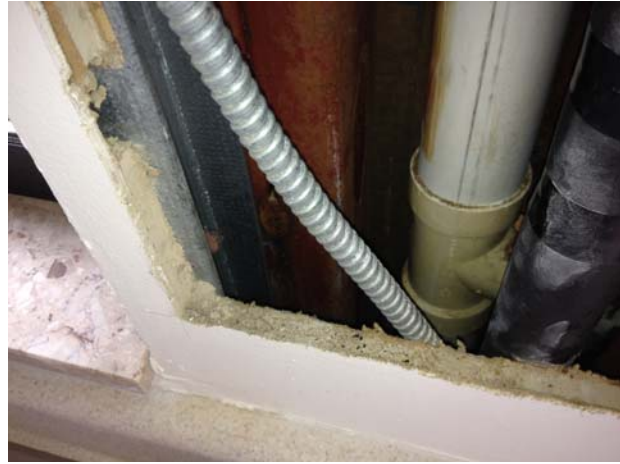
EX. CONDUIT WITHIN METAL FRAMING

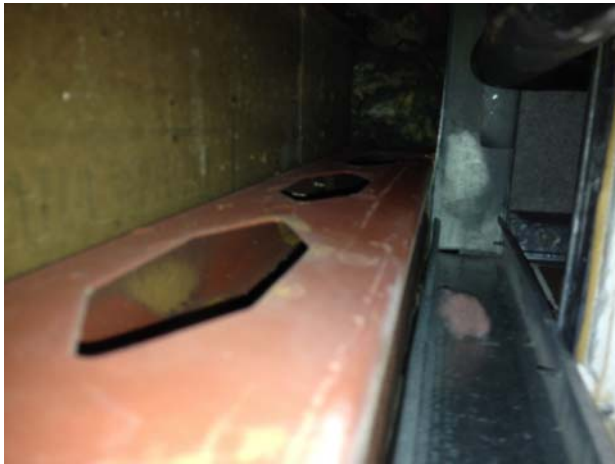
EX. FRAMING EXTENDING PAST CONCRETE PLANK FLOOR

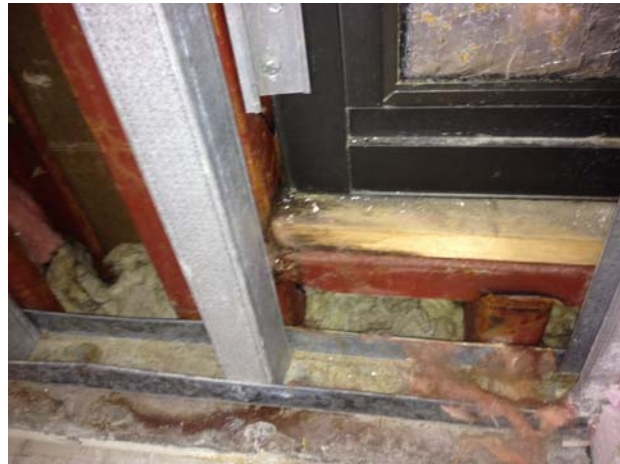
EX. INTERIOR FRAMING AND COLD METAL BEYOND

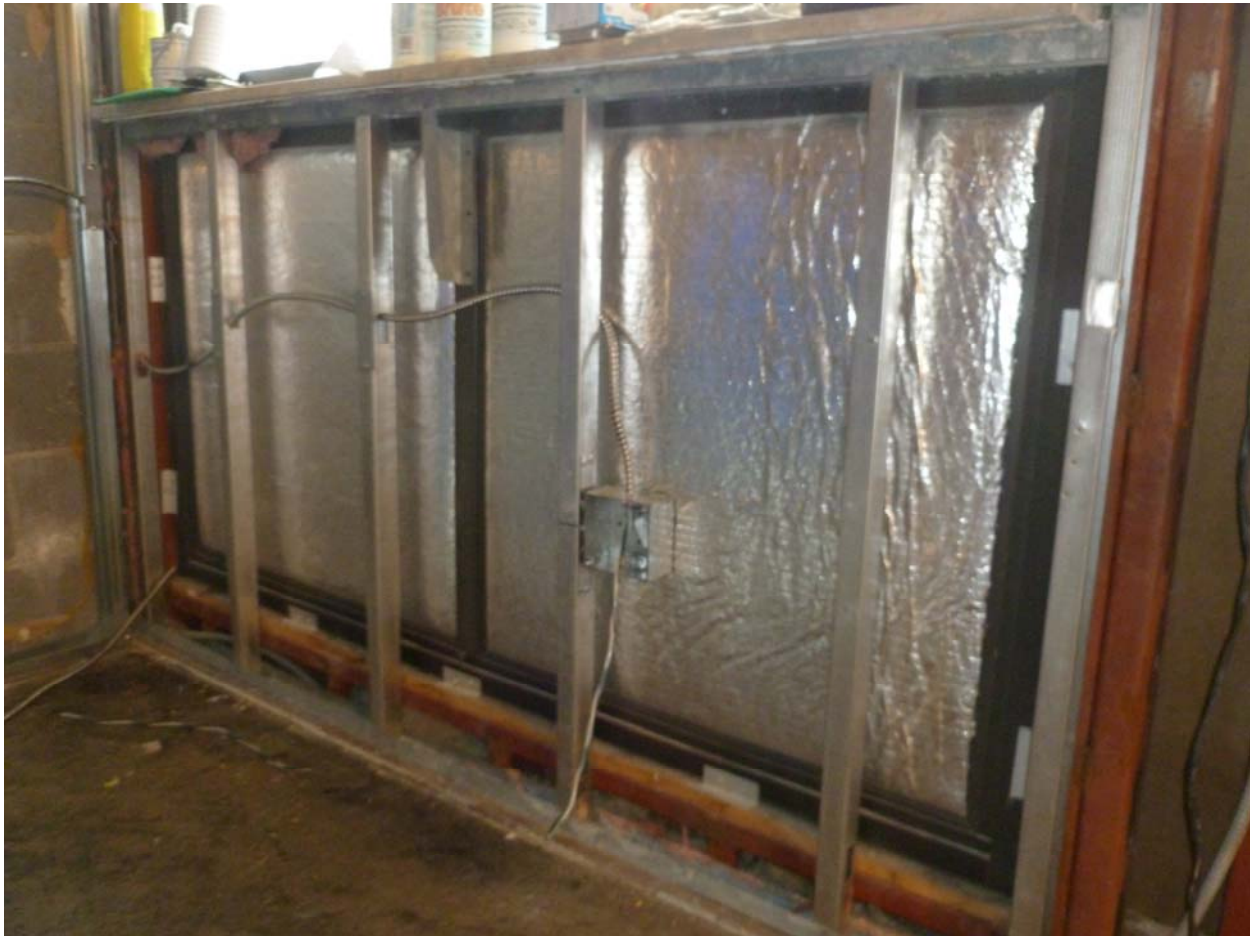
TYPICAL INTERIOR METAL FRAMING AND COLD FORMED METAL FRAMING BELOW WINDOW
