### **Arch Street Duplex Renovation AMP-39 IFB #600-40-24**

#### **ADDENDUM NO. 1**

Re: Fire Escape Condition Assessment  
1204 Arch Street  
Pittsburgh, PA 15212  
Providence Project #242328

Re: Fire Escape Condition Assessment  
1206 Arch Street  
Pittsburgh, PA 15212  
Providence Project #242328

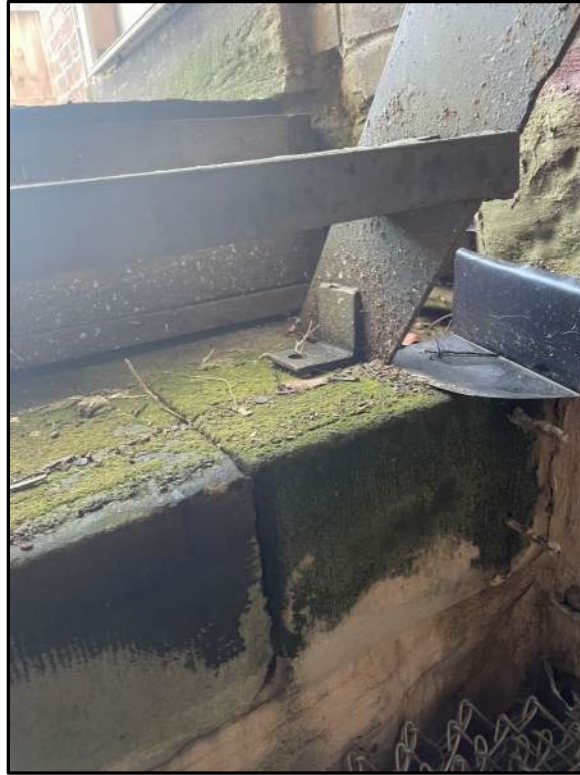
**Photo 1.** Missing Stair Base Attachment

1. Providence observed steel angles welded to the base of the lowest stair stringer that had missing anchor bolts. Providence recommends adding mechanical anchors to fix the base of the stair stringer to the concrete landing similar to Hilti Kwik Bolt 3.
2. Portions of the metal grating and steel pieces had minor corrosion and peeled paint. Providence recommends cleaning the exposed steel and painting the steel with a corrosion inhibitor primer.

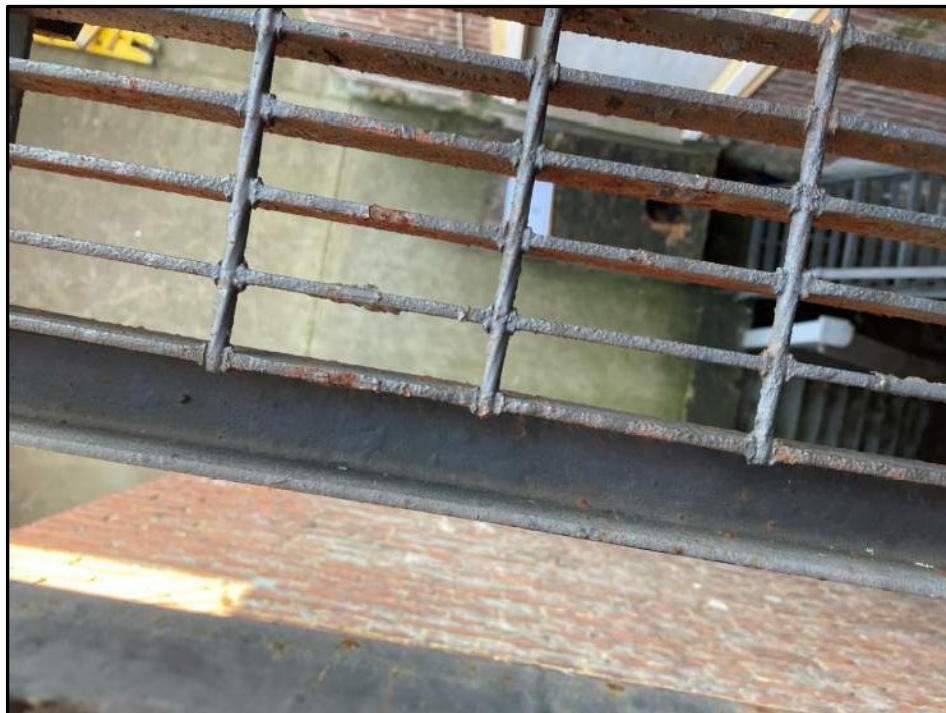
**Photo 2.** Typical Platform Grating

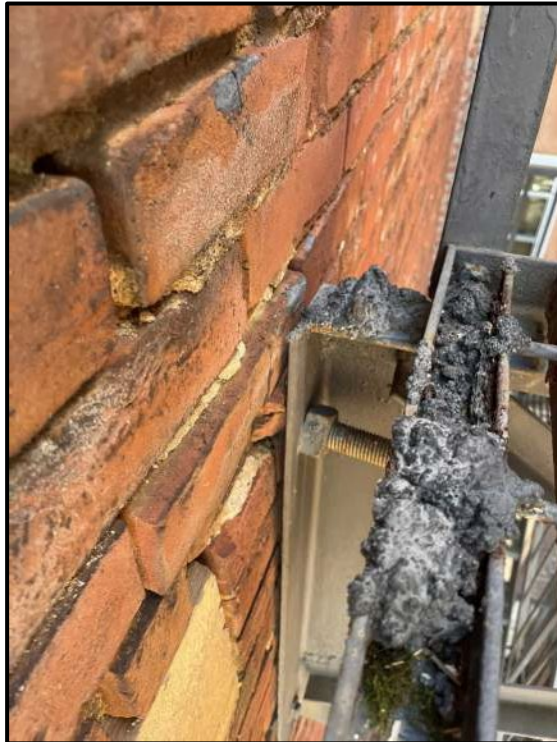
**Photo 3.** Typical Platform Brace Connection

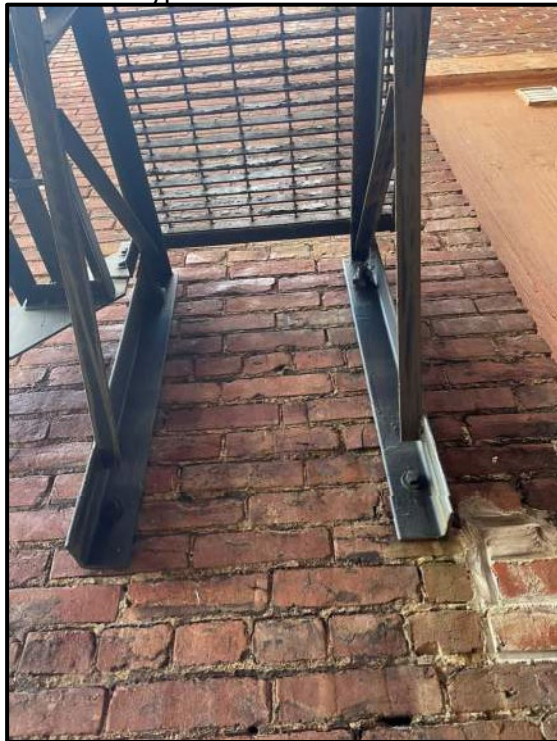
**Photo 4.** Typical Platform Brace Connection

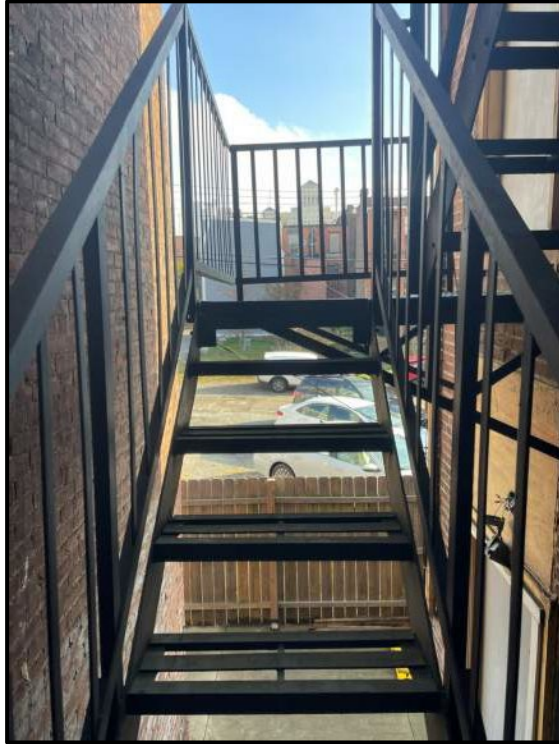
**Photo 5.** Typical Platform Landing

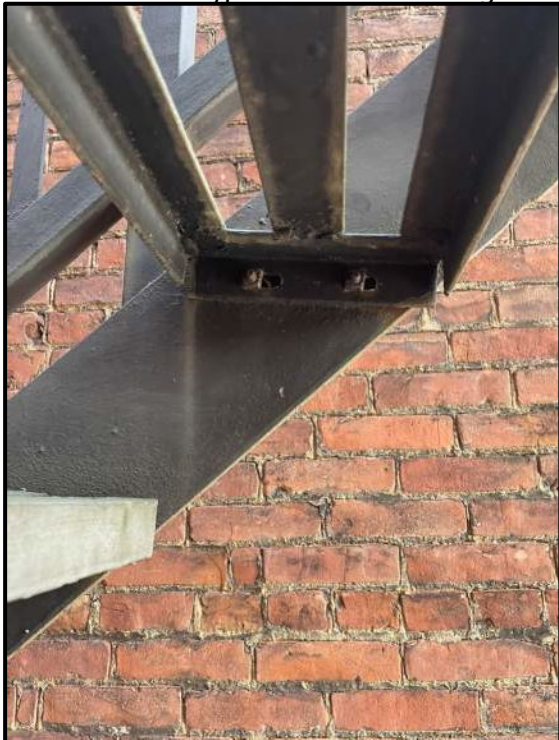
**Photo 6.** Typical Stair Tread Attachment to Stringer

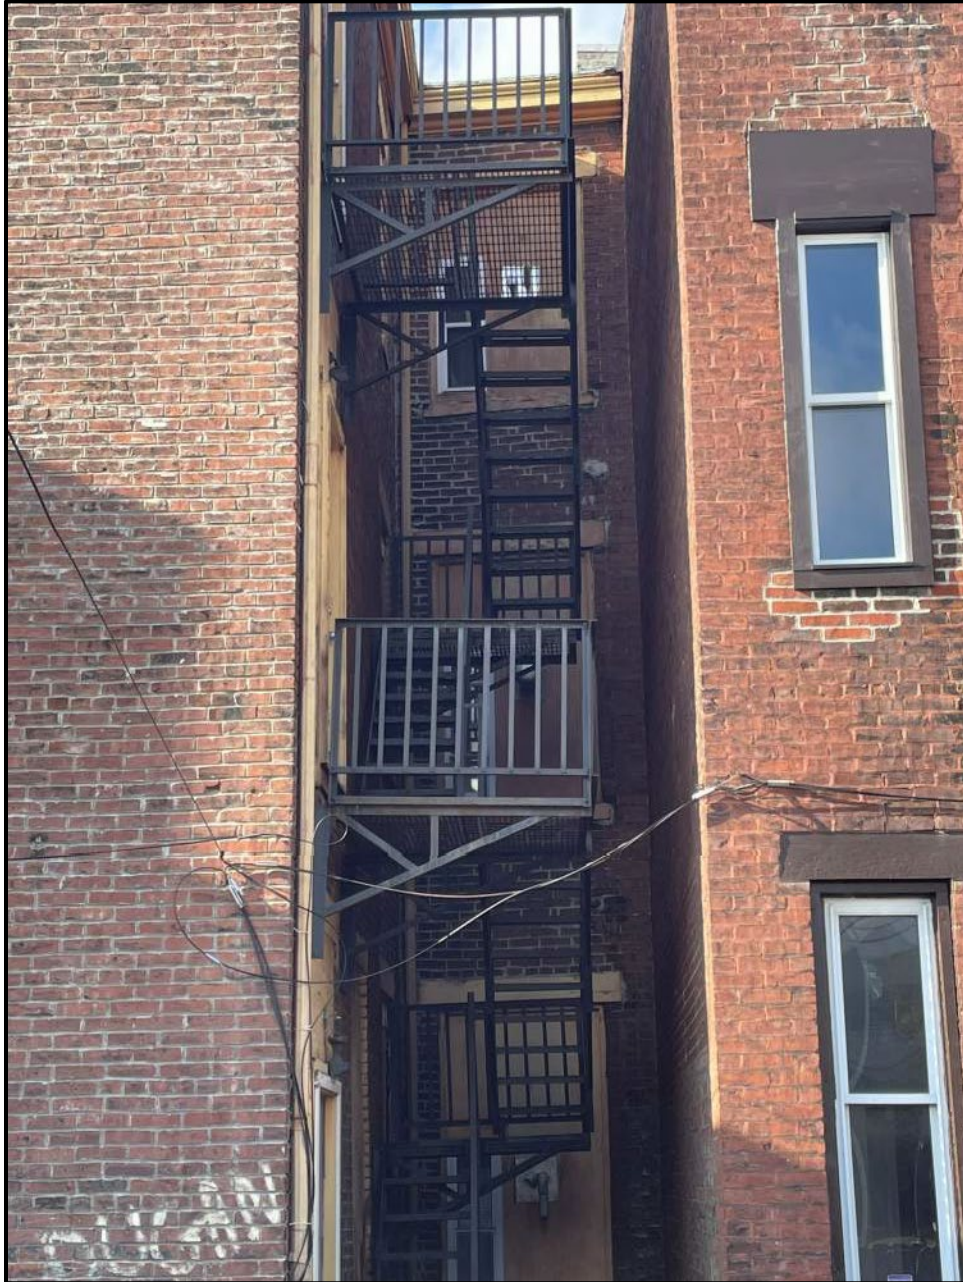
**Photo 7.** Typical Elevation

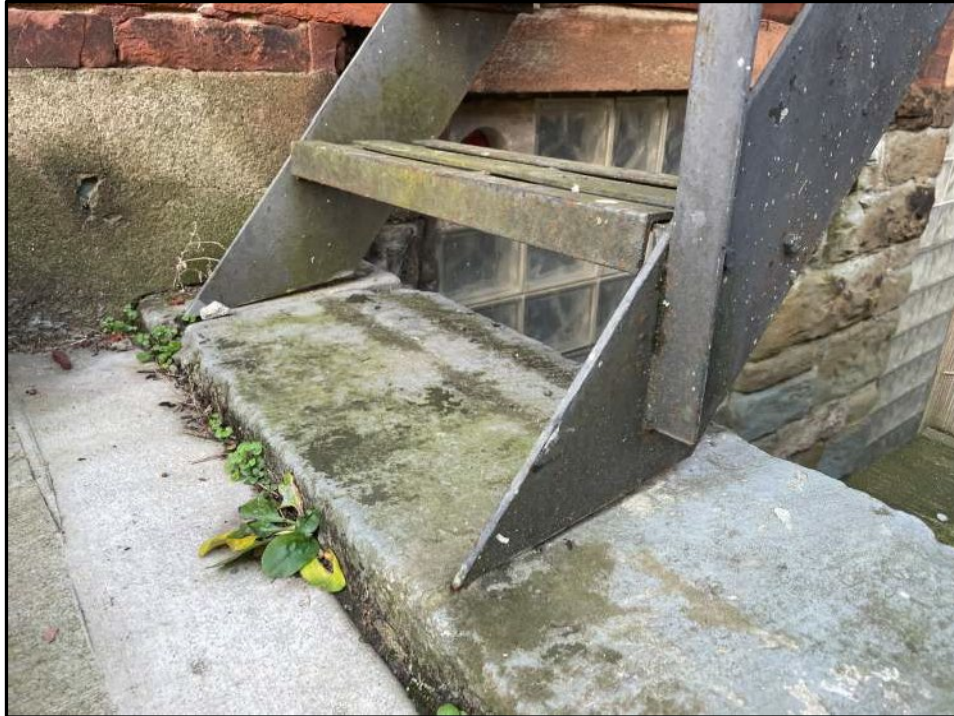
**Photo 1.** Missing Stair Base Attachment

1. Providence observed the stair stringers at the base with no attachment to the slab on grade. The base of the stairs was loose and did not have steel angles welded for anchor bolts. Providence recommends adding a L3x3x5/16x 0'-4" angle with mechanical anchors to fix the base of each stair stringer to the concrete landing. Approved anchors shall be similar to Hilti Kwik Bolt 3.
2. Portions of the metal grating and steel pieces had minor corrosion and peeled paint. Providence recommends cleaning the exposed steel and painting the steel with a corrosion inhibitor primer.

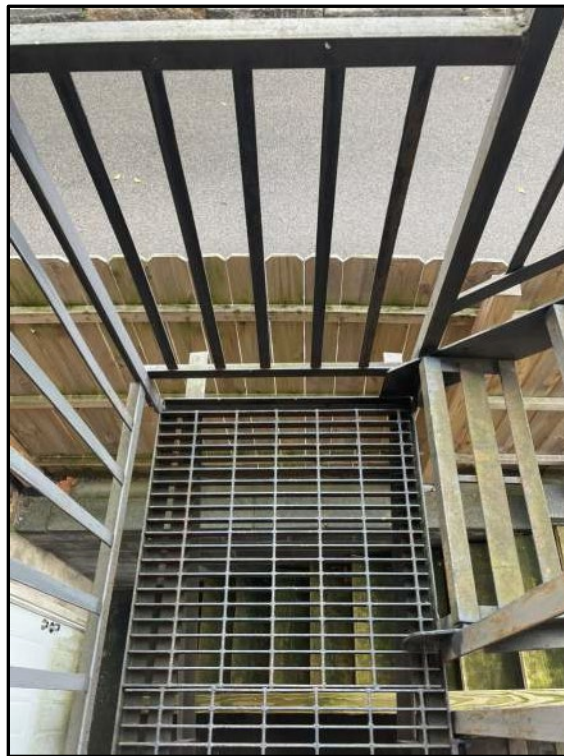
**Photo 2.** Typical Platform Grating

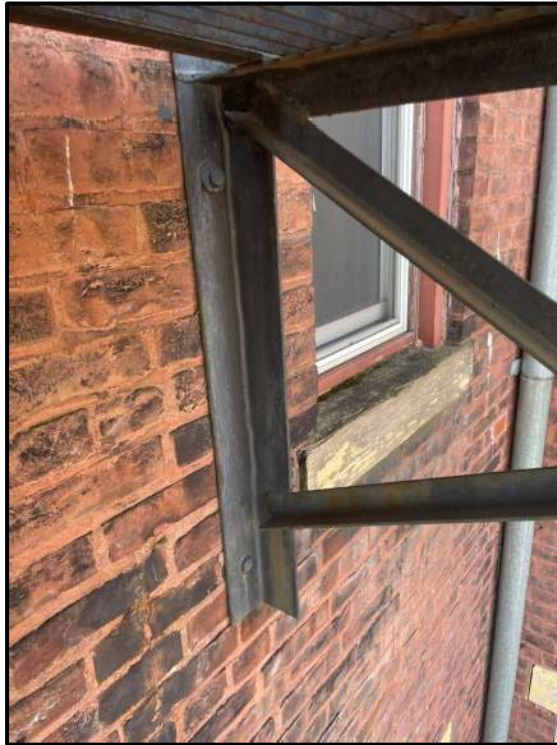
**Photo 3.** Typical Platform Brace Connection

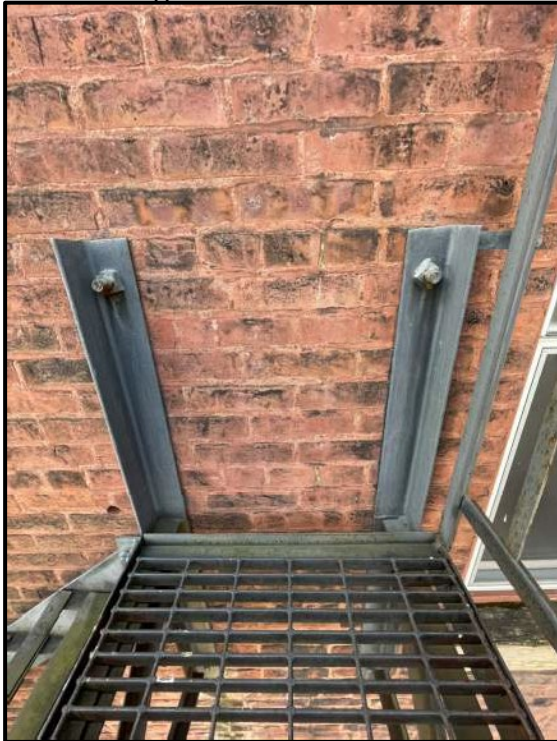
**Photo 4.** Typical Platform Brace Connection

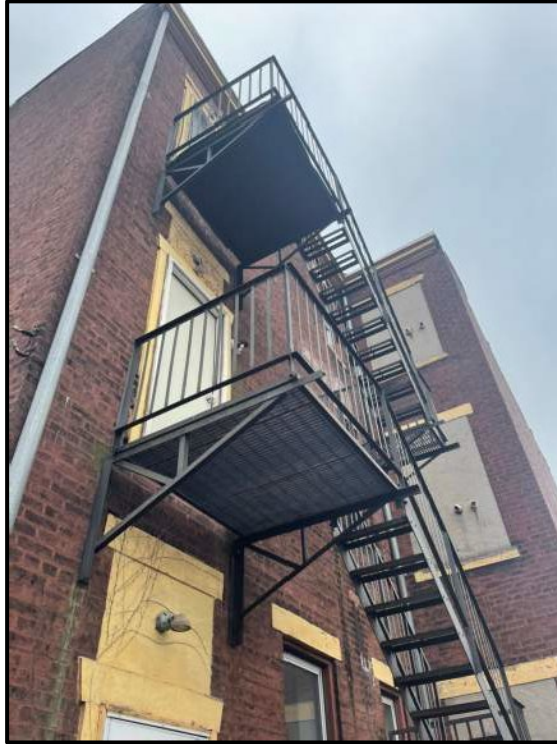
**Photo 5.** Typical Platform Landing

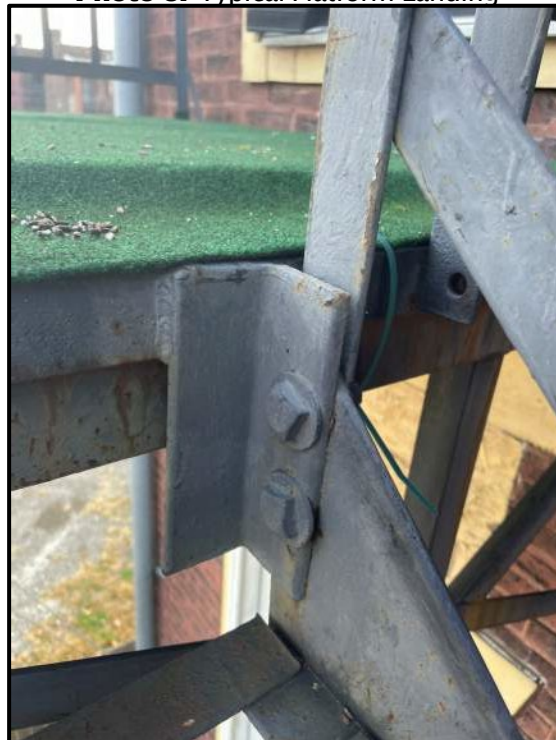
**Photo 6.** Typical Stair Stringer Attachment to Landing

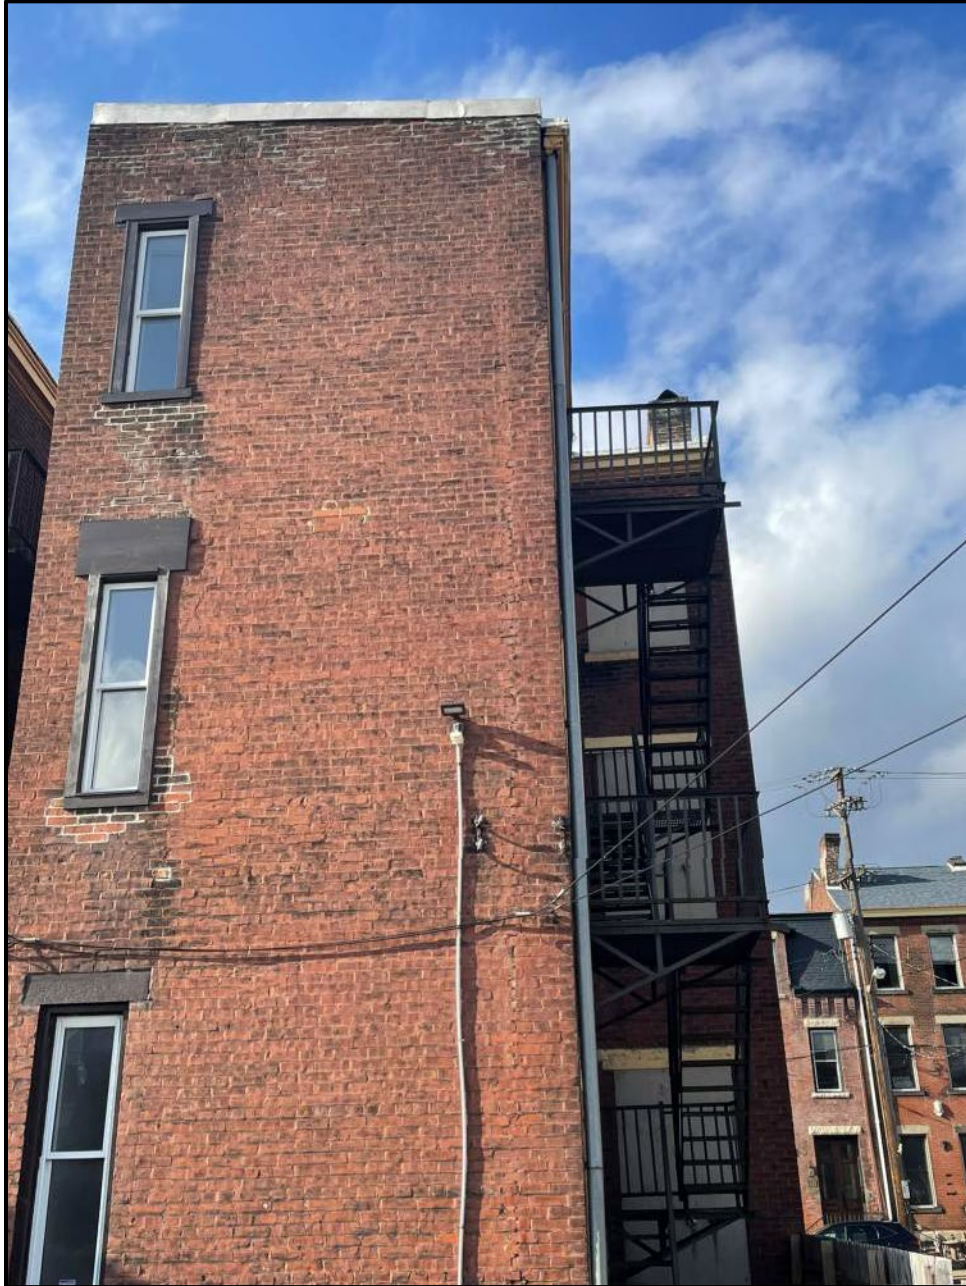
**Photo 7.** Typical Elevation
