## ASBESTOS AND POTENTIALLY REGULATED MATERIALS SURVEY

**Murray Towers**  
**28252 Murray Avenue**  
**Pittsburgh, Pennsylvania 15217**

July 30, 2023

PSI Project Number: 08166046

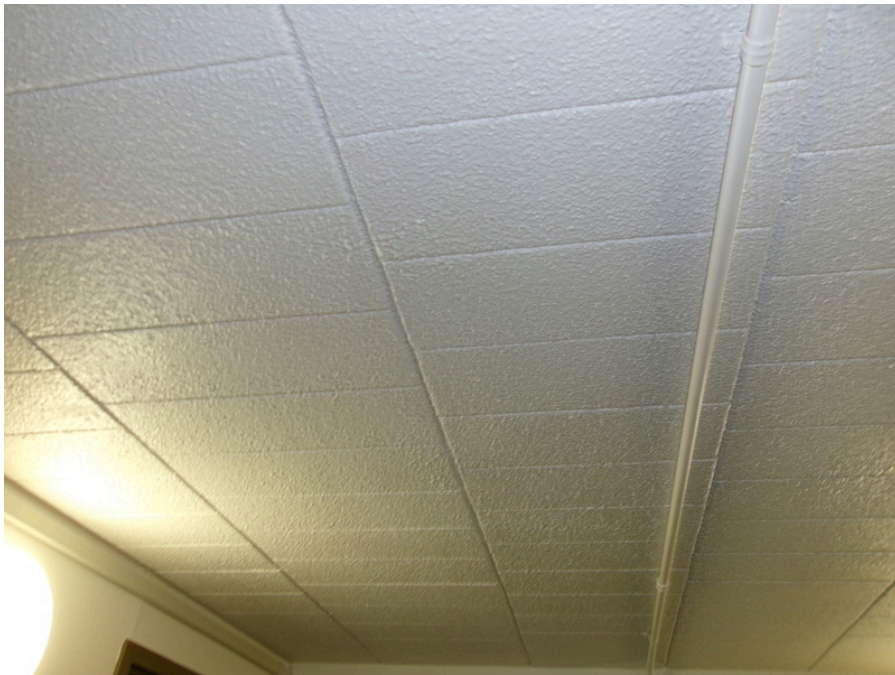
Photo 6: ACM Surfacing from Previous Survey
